Navajo Abandoned Uranium Mine

Site Screen Report

**Mine Name: Claim 7
Mine ID: 81**

Weston Solutions, Inc.

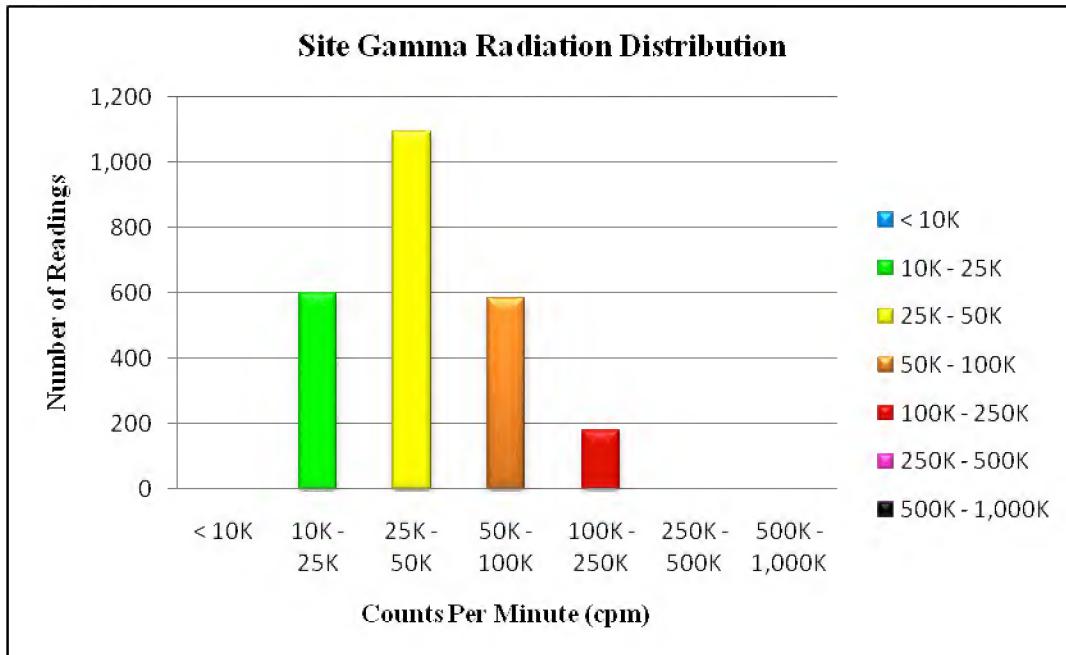
Highest gamma radiation measurement: 196,062 counts per minute (cpm)

Background Average: 14,986 cpm **Two Times Background:** 29,972 cpm

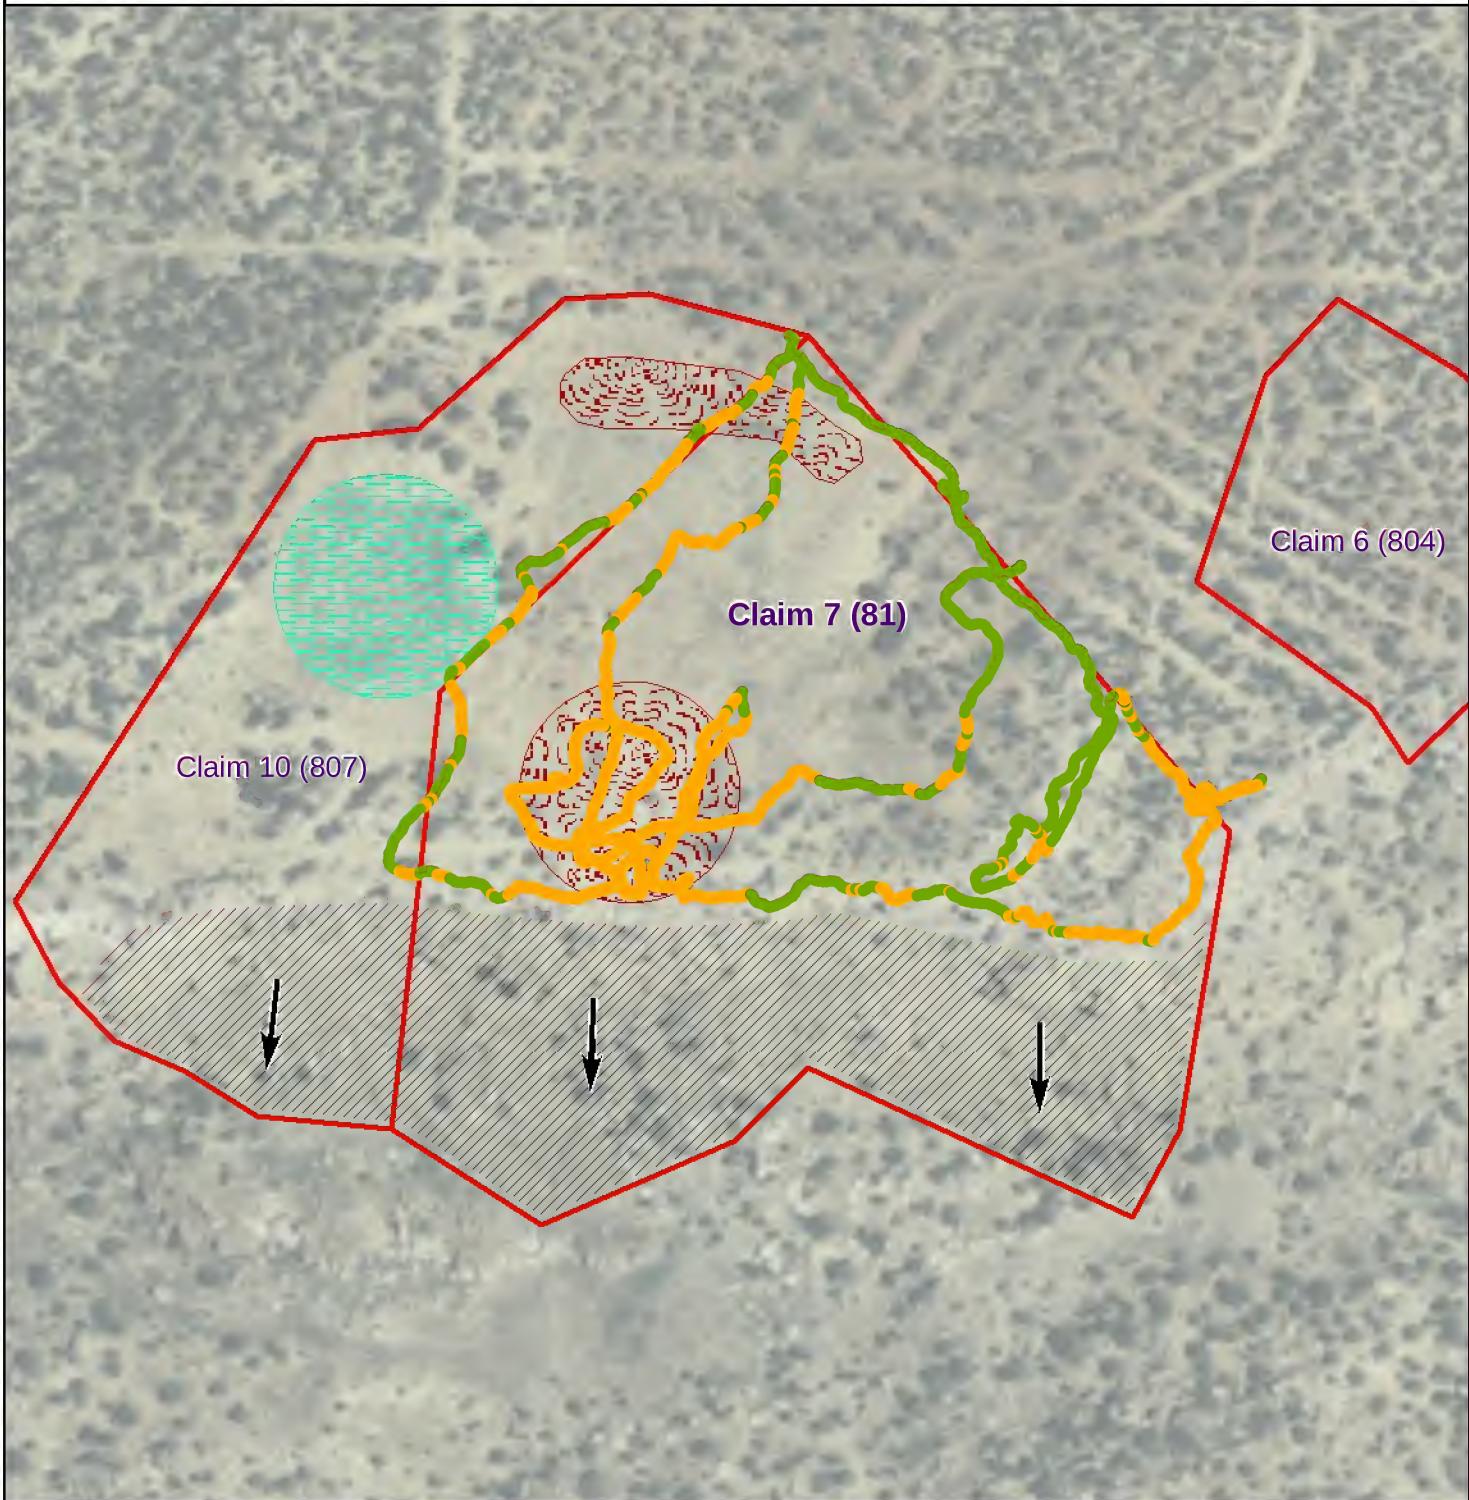
Figure 1 - Gamma Radiation Measurements, Above Two Times Background
Claim 7 (81)
Tselani / Tachee Chapters, Navajo Nation

A total of 2,455 gamma radiation measurements were collected from the mine site, ranging from 14,356 cpm to 196,062 cpm. Measurements collected in the vicinity of the waste rock were found at a maximum level of approximately 200,000 cpm. The measurements are represented in Figures 1 and 2.
